Storm-Tide Elevations Produced by Hurricane Andrew Along the Southern Florida Coasts, August 24, 1992

Open-File Report 94-116

By MITCHELL H. MURRAY

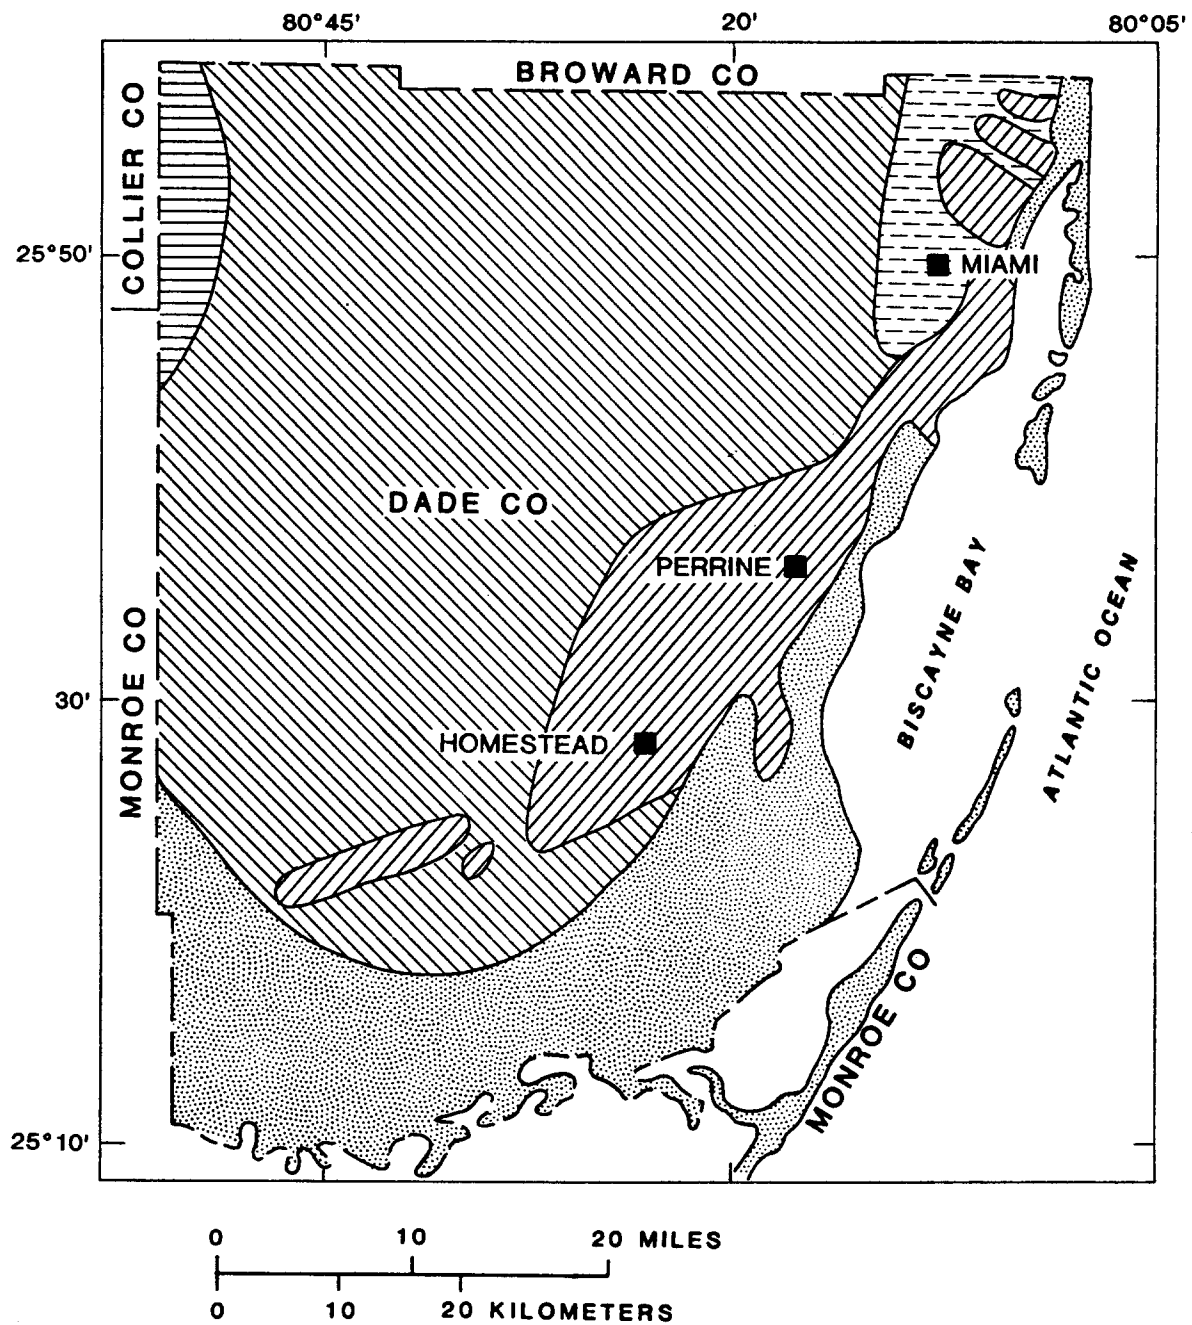
Figure 3. Physiographic features of Dade County prior to development (from Fish and Stewart, 1991).

Physiographic features such as the Atlantic Coastal Ridge (fig. 3) have significantly controlled the environment, drainage, and ultimately the land use along coastal Dade County. The Atlantic Coastal Ridge, a narrow ridge 2 to 10 mi wide that parallels the coast, forms the highest ground in the county. Elevations along the ridge range from about 8 to 15 ft above sea level between Homestead and north Miami to 20 ft above sea level or greater in some places (Fish and

Both the inner and outer coast elevations are shown on the alongshore profile in figure 5 to illustrate the effect of the marshes (fig. 3) and barrier islands on the storm tide. Storm-tide elevations from the Broad Causeway to S.W. 111 Street and from Princeton Canal to Barnes Sound were relatively low (generally less than 8 ft above sea level), and the highest storm-tide elevations (17 ft above sea level) were in the vicinity of S.W. 180th Terrace (fig. 6, site 39), east of Old Cutler Road (Burger King Corporation) in Perrine. The area of highest storm-tide elevations was in an area of the coastal mainland that is unprotected by barrier islands and was at the outer northern eyewall edge of the hurricane where sustained winds reached 145 mi/hr. Maximum storm tides occur at different times and locations due to complex interaction of wind and wave dynamics. Because of this complexity, an analysis of the timing and elevation of peak storm tides throughout the study area is beyond the scope of this report.

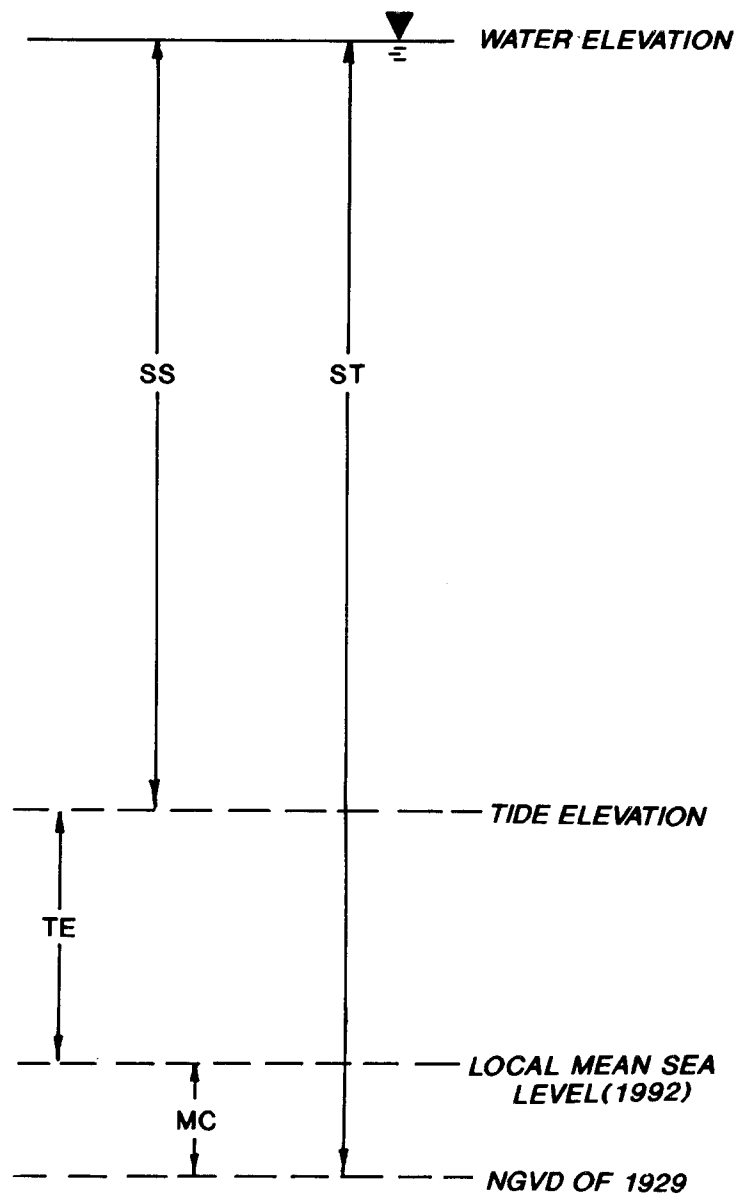
MC=DIFFERENCE BETWEEN NGVD OF 1929 AND LOCAL MEAN SEA LEVEL (1992)

TE= ELEVATION OF TIDE ABOVE LOCAL MEAN SEA LEVEL(1992)
AT TIME OF PEAK STORM-TIDE ELEVATION

ST=STORM TIDE, WATER ELEVATION ABOVE NATIONAL GEODETIC
VERTICAL DATUM OF 1929 (NGVD OF 1929)

SS=STORM-SURGE ELEVATION

$$SS=ST-(MC+TE)$$

Figure 4. Storm-surge elevation computation.

Because sea levels have been rising in varying amounts with respect to location and time since 1929, the local mean sea level is now higher than NGVD of 1929. The most recent computation of sea level at various locations was in 1978 using hourly water-level readings for the time period 1960-78. In Miami, sea level in 1978 was 0.43 ft higher than NGVD of 1929. Extrapolating the data to 1992 would give a rise of about 0.55 ft. The relations among NGVD of 1929, local mean sea level, tide elevations, and storm surge as well as the equation used to calculate storm surge are shown in figure 4.

of Biscayne Bay at the time the storm hit the coast was 1.3 to 1.5 ft. If storm tide (ST) represents the height of the high-water surface above NGVD of 1929, MC represents the estimated difference between NGVD of 1929 and local mean sea level of 1992 (0.55 ft), and TE represents the elevation of the astronomical tide above local mean sea level of 1992 (1.3 to 1.5 ft), the storm-surge elevation (SS) can be determined using the equation in figure 4 as follows:

$$SS = ST - (MC + TE) \quad (1)$$

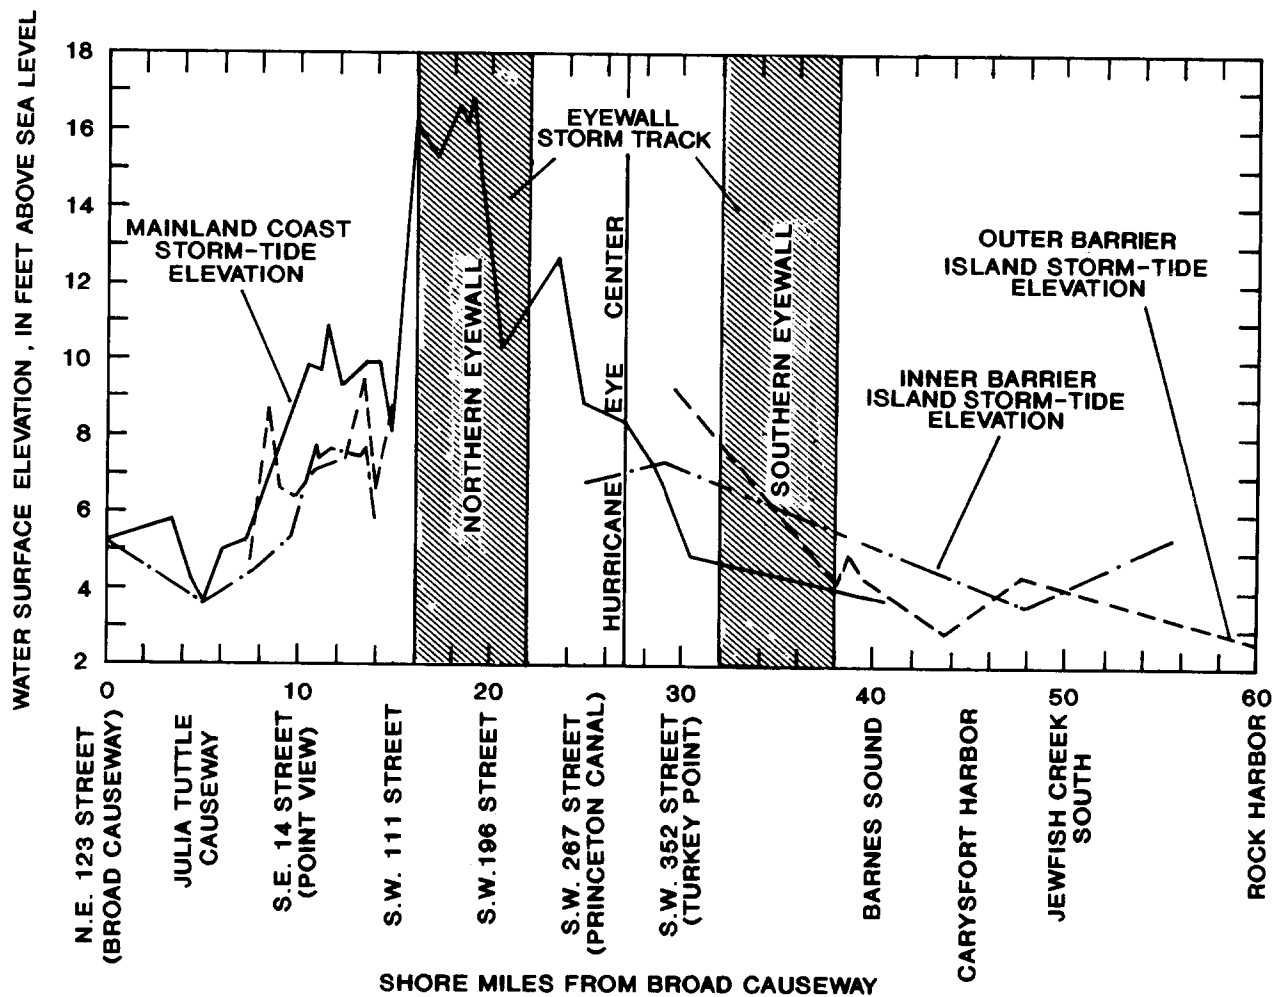
Figure 5. Alongshore storm-tide elevations for the mainland coast and the outer and inner barrier island coasts of southeastern Florida.

A plot of average storm-tide elevations for selected high-water marks for the mainland coast, inner barrier island coast, and outer barrier island coast of southeastern Florida is shown in figure 5. For this report, these coasts are defined as follows:

The mileage baseline used to prepare figure 5 is shown in figure 6. The baseline is oriented in a north-south direction so as to be aligned perpendicular to the east-west streets of the urban areas to facilitate interpolations of storm-tide elevations. The water-surface elevation data used to prepare figure 5, where possible, were obtained from inside high-water marks located along the east-west transects. Outside high-water marks were used when inside marks were unavailable.

The alongshore elevation data, plotted on figure 5, are presented in table 2. The distances to open water from the mainland and the inner and outer barrier island high-water marks are also given in table 2. The distance to open water is defined, for the purposes of this report, as the shortest (straight line) distance over which the surge would pass to reach the mainland and

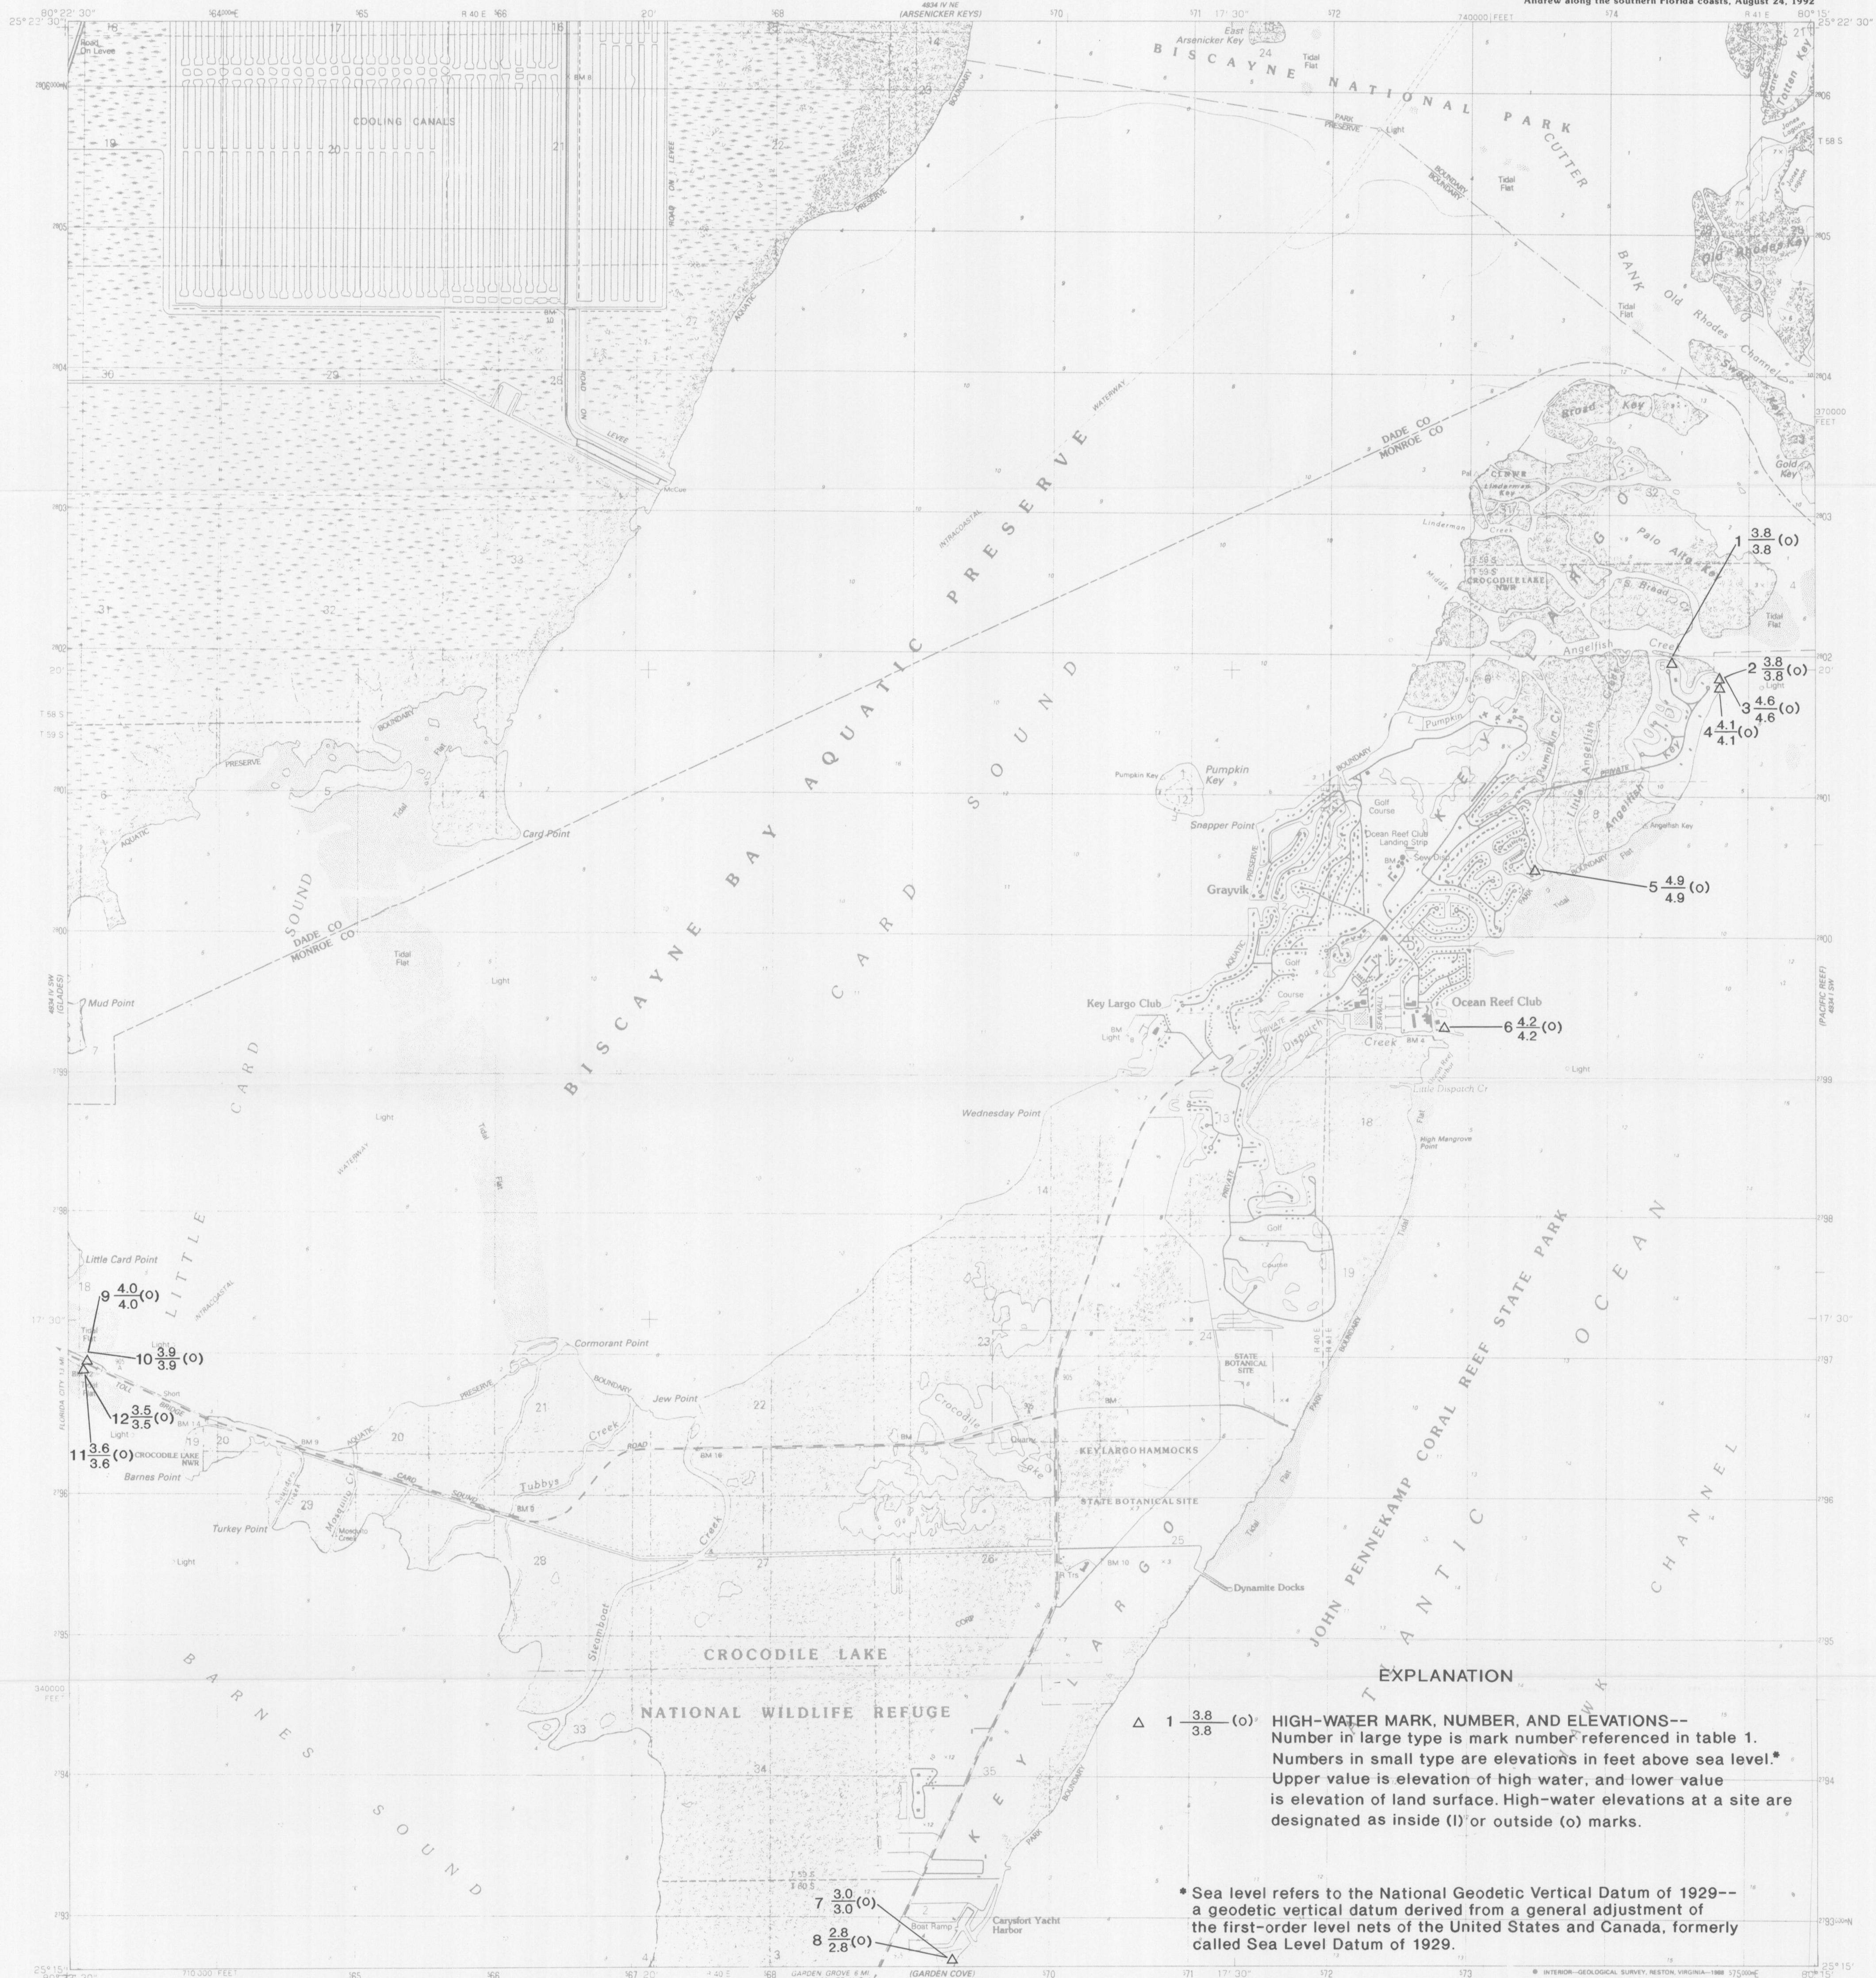
PLATE 10.-- MAP SHOWING WATER-SURFACE ELEVATIONS AND HIGH-WATER MARK LOCATIONS IN AREAS AFFECTED BY
HURRICANE ANDREW, CARD SOUND, FLORIDA, QUADRANGLE.

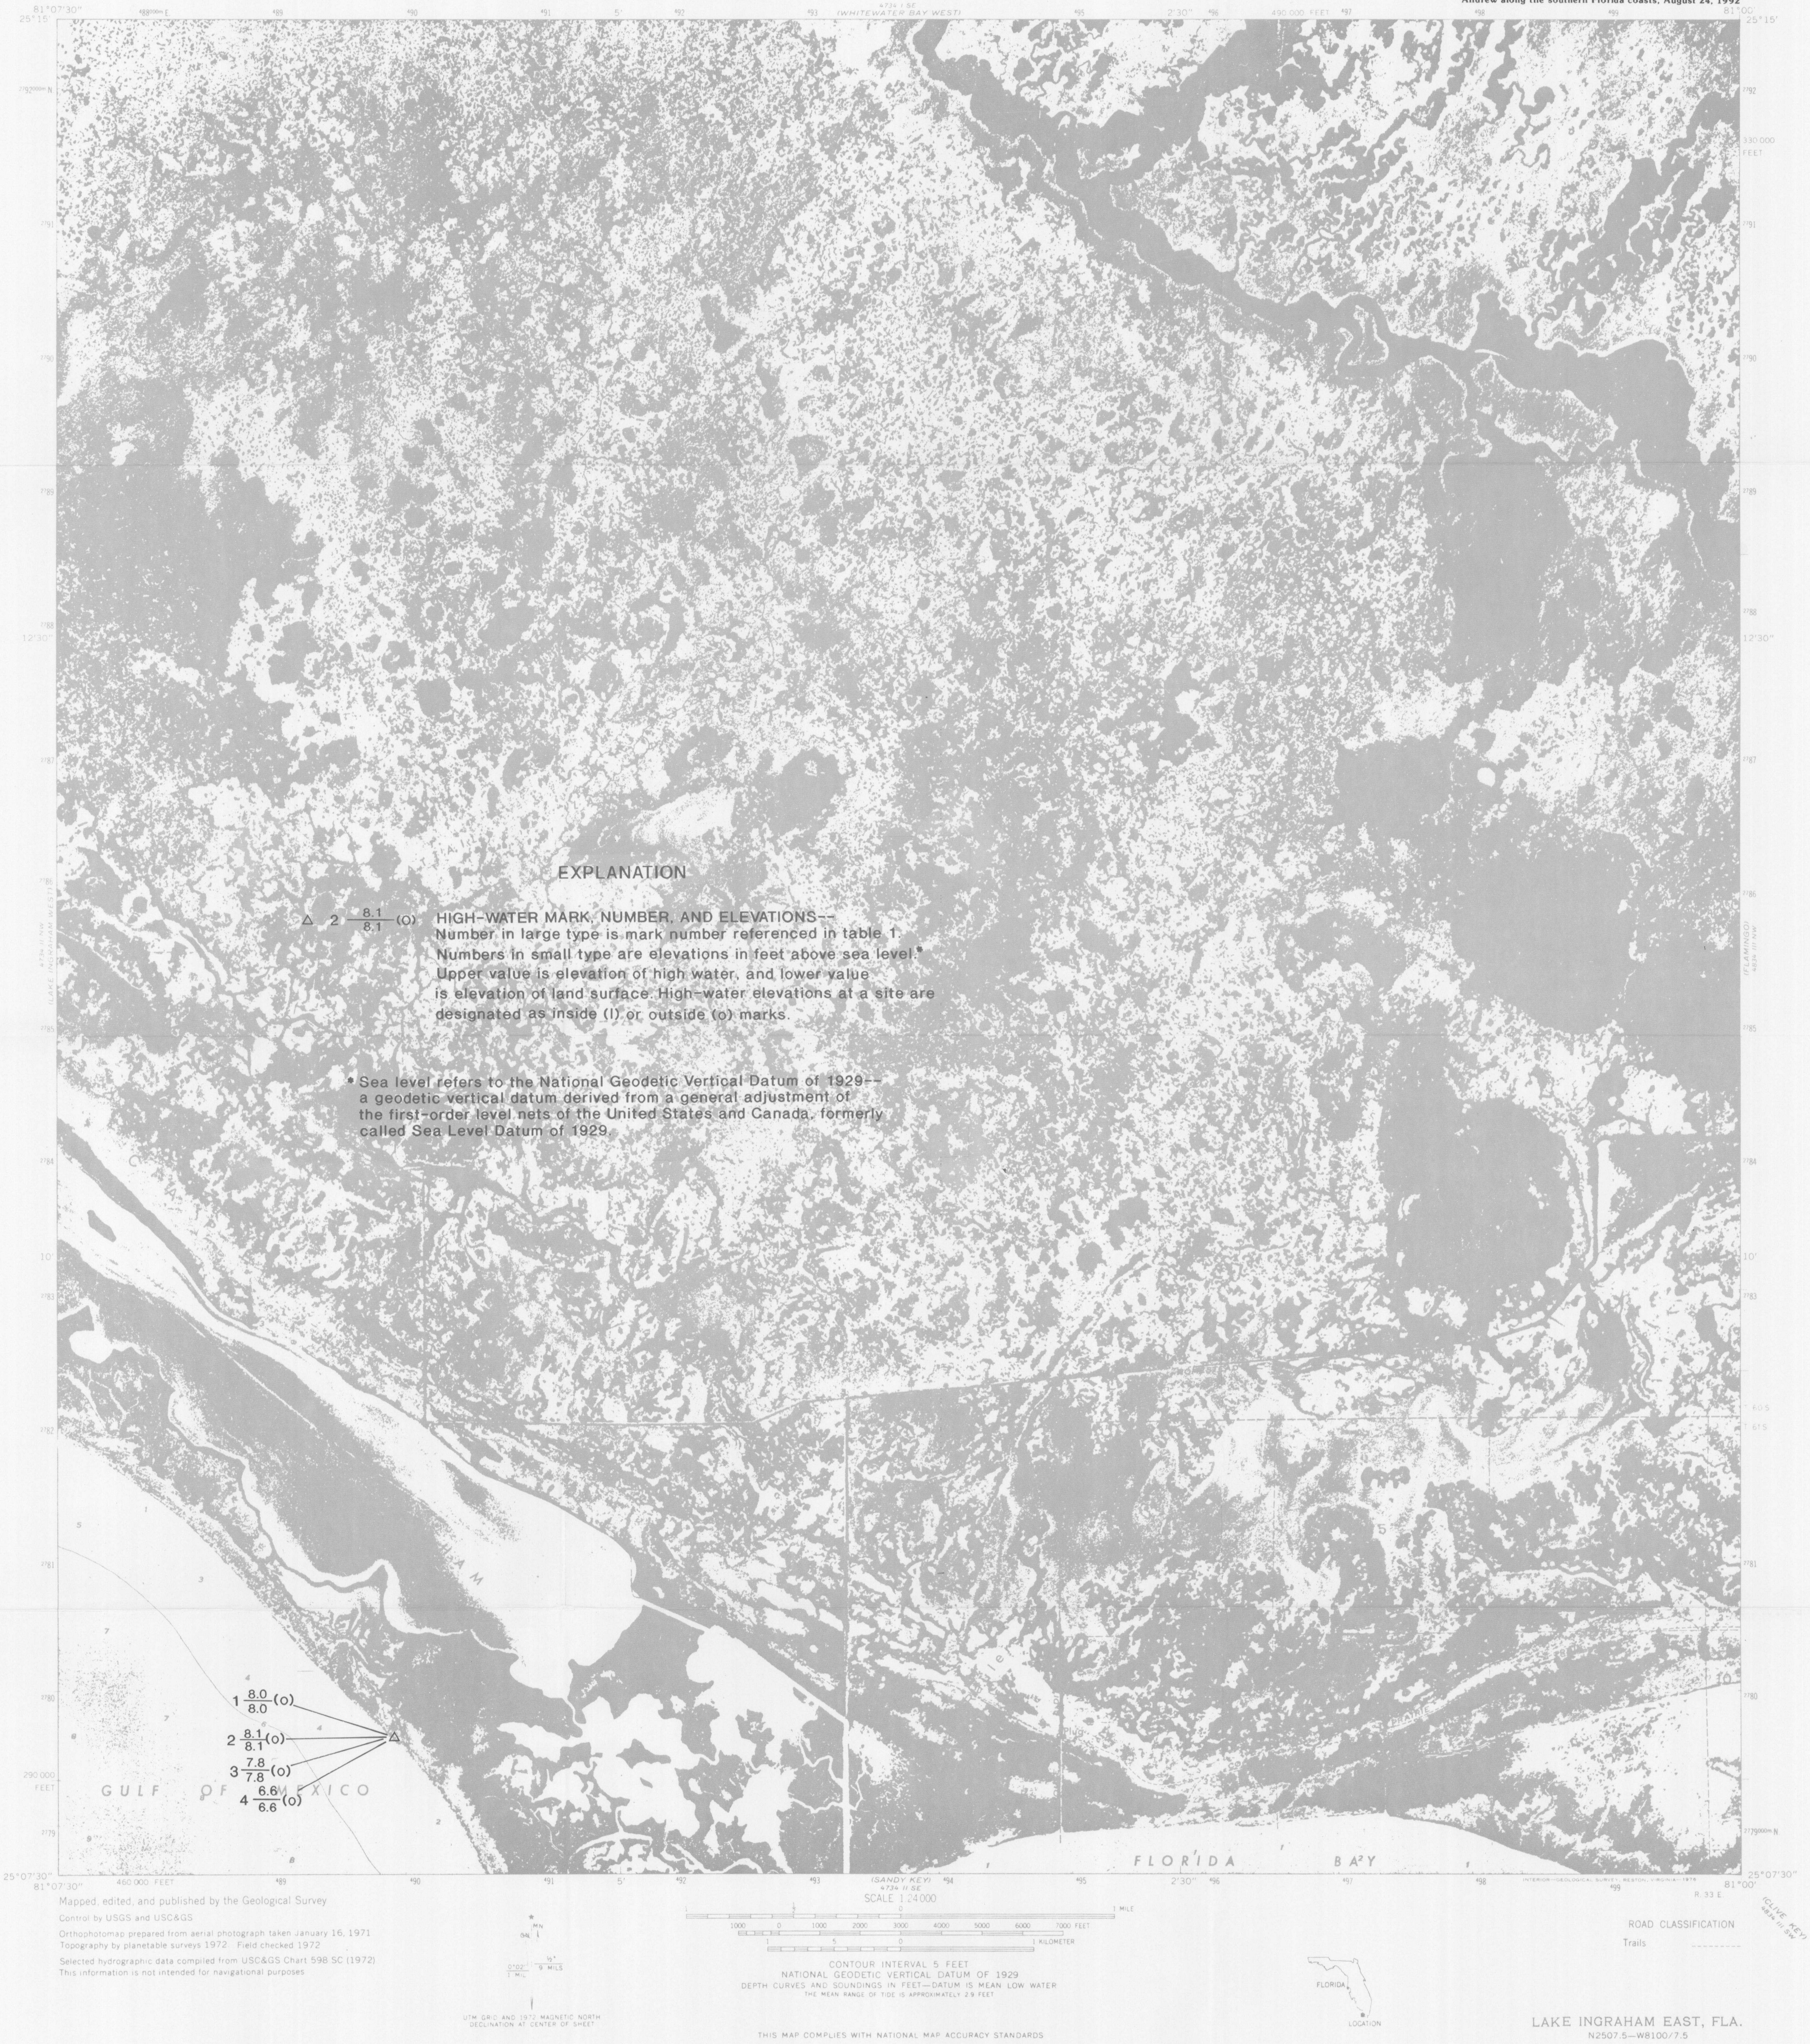
PLATE 15.-- MAP SHOWING WATER-SURFACE ELEVATIONS AND HIGH-WATER MARK LOCATIONS IN AREAS AFFECTED BY
HURRICANE ANDREW, LAKE INGRAHAM EAST, FLORIDA, QUADRANGLE.

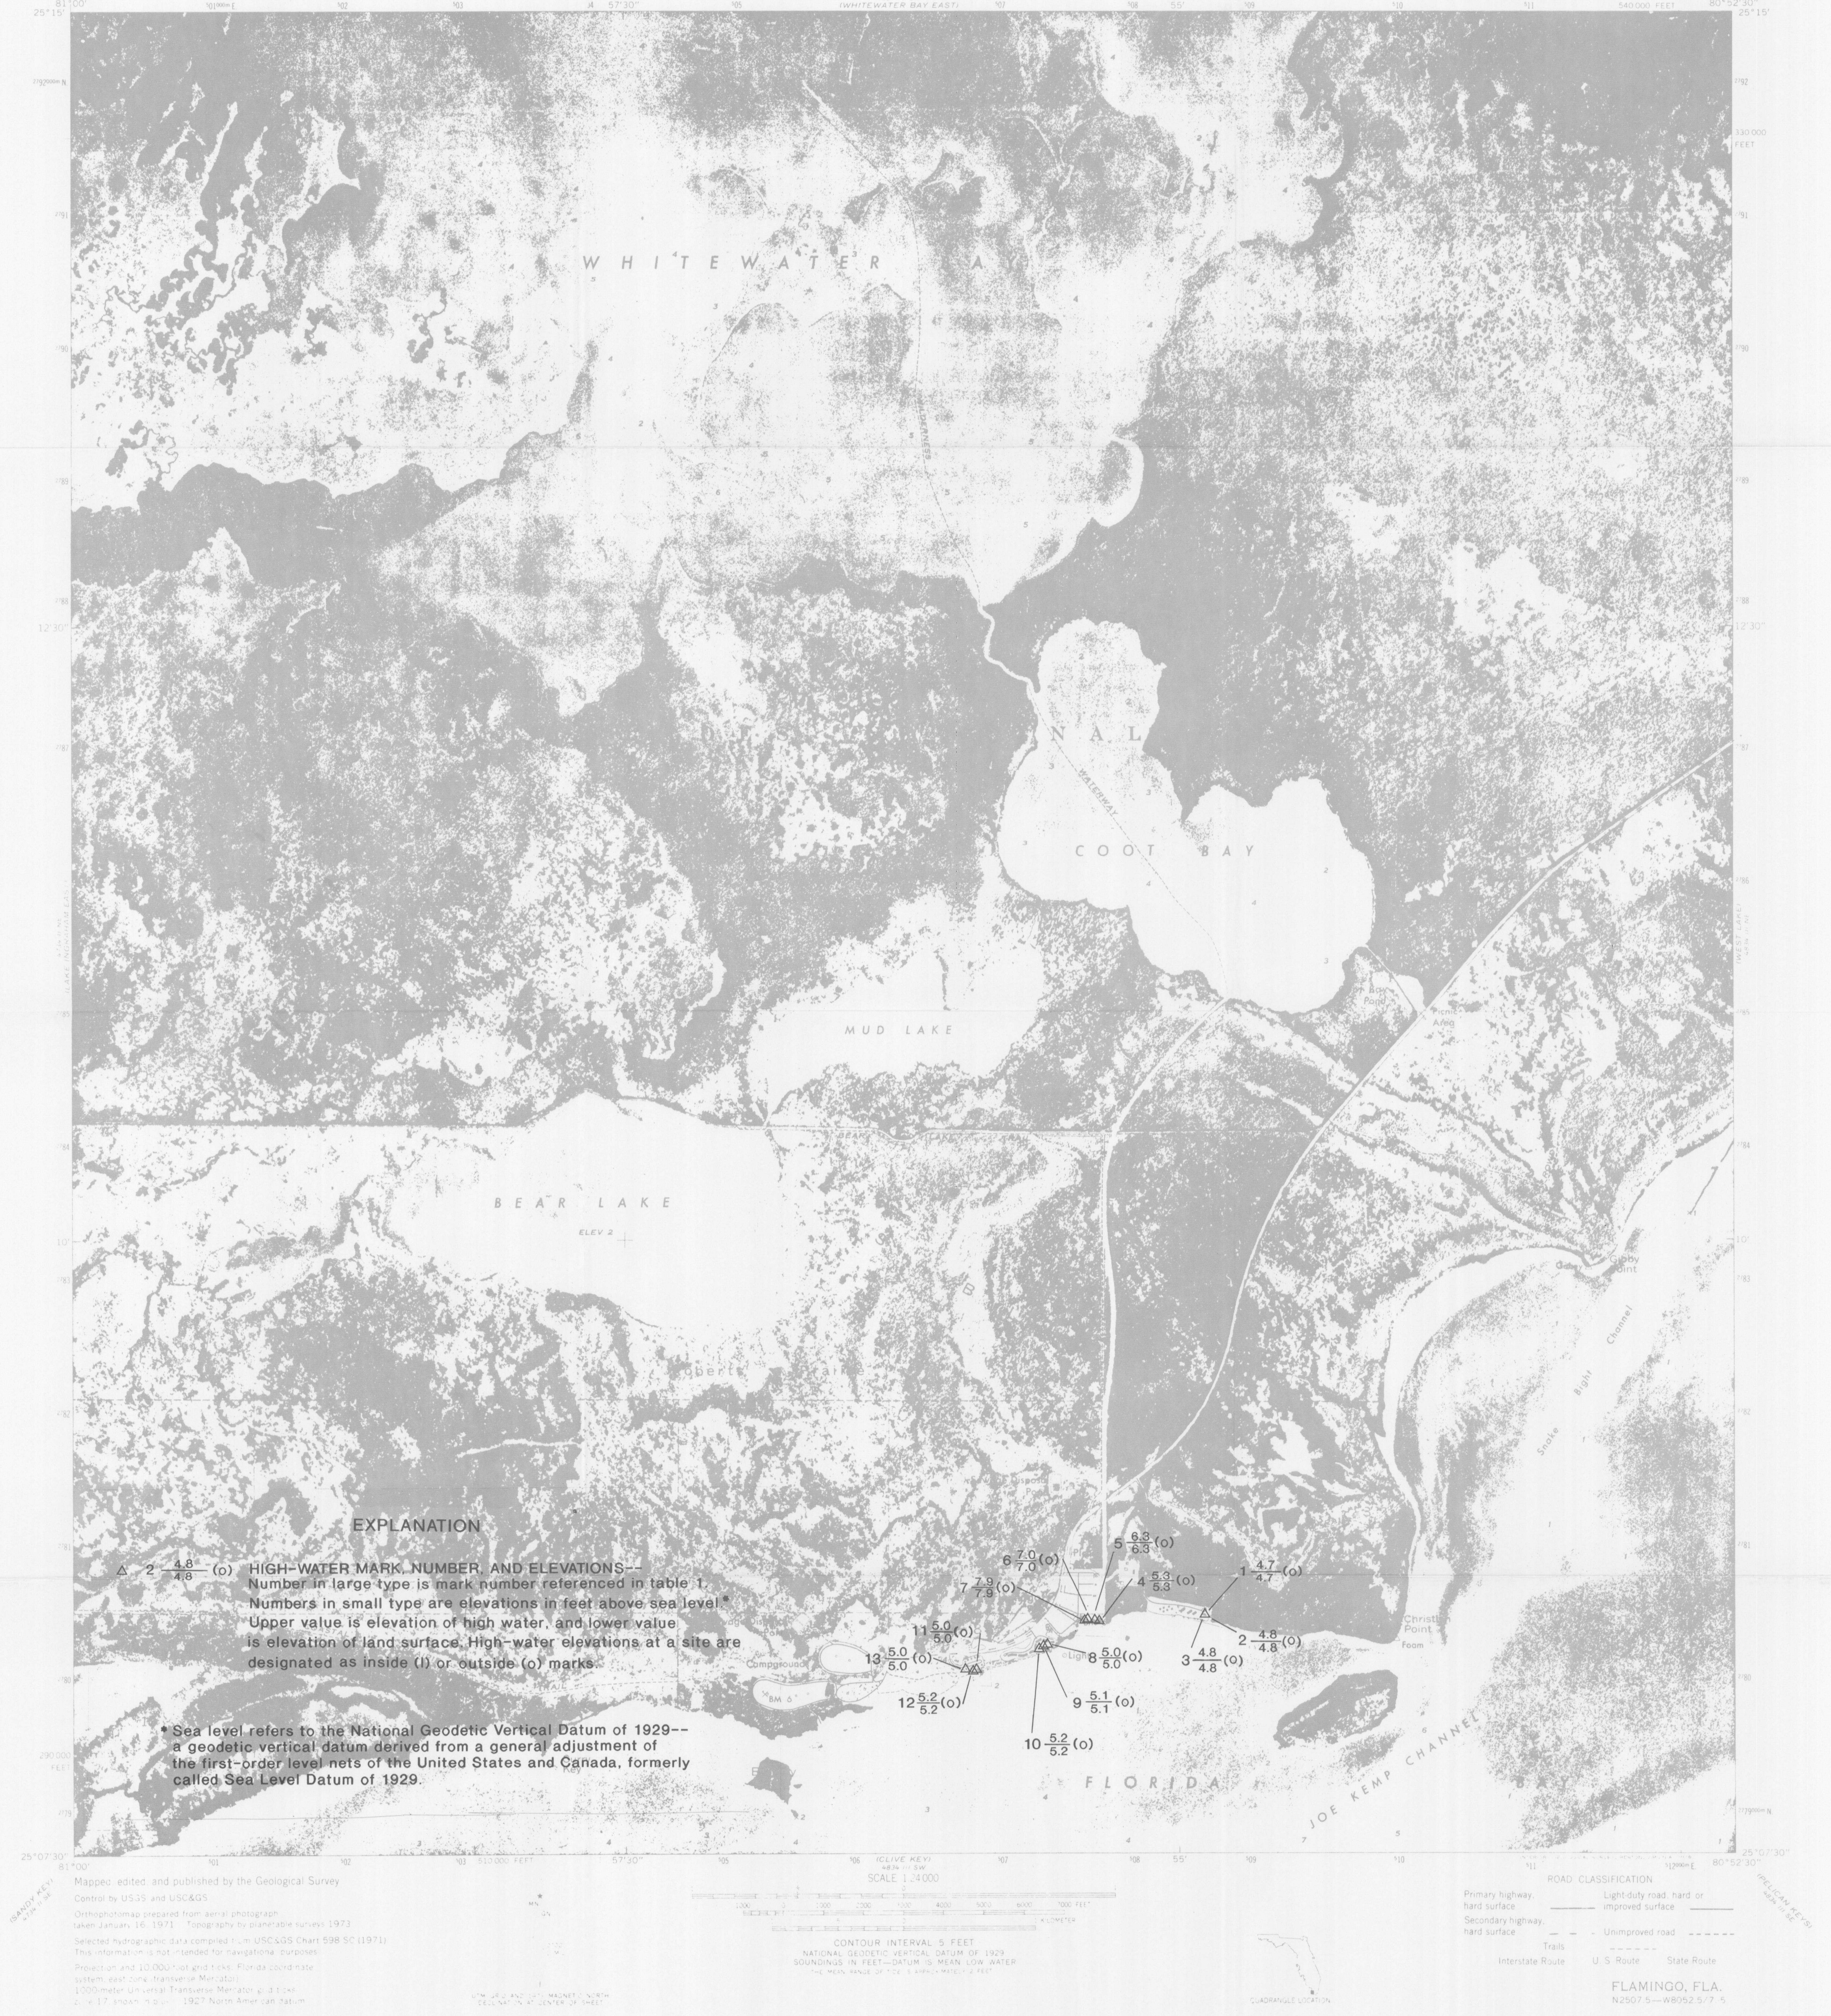
PLATE 16.--MAP SHOWING WATER-SURFACE ELEVATIONS AND HIGH-WATER MARK LOCATIONS IN AREAS AFFECTED BY
HURRICANE ANDREW, FLAMINGO, FLORIDA, QUADRANGLE.

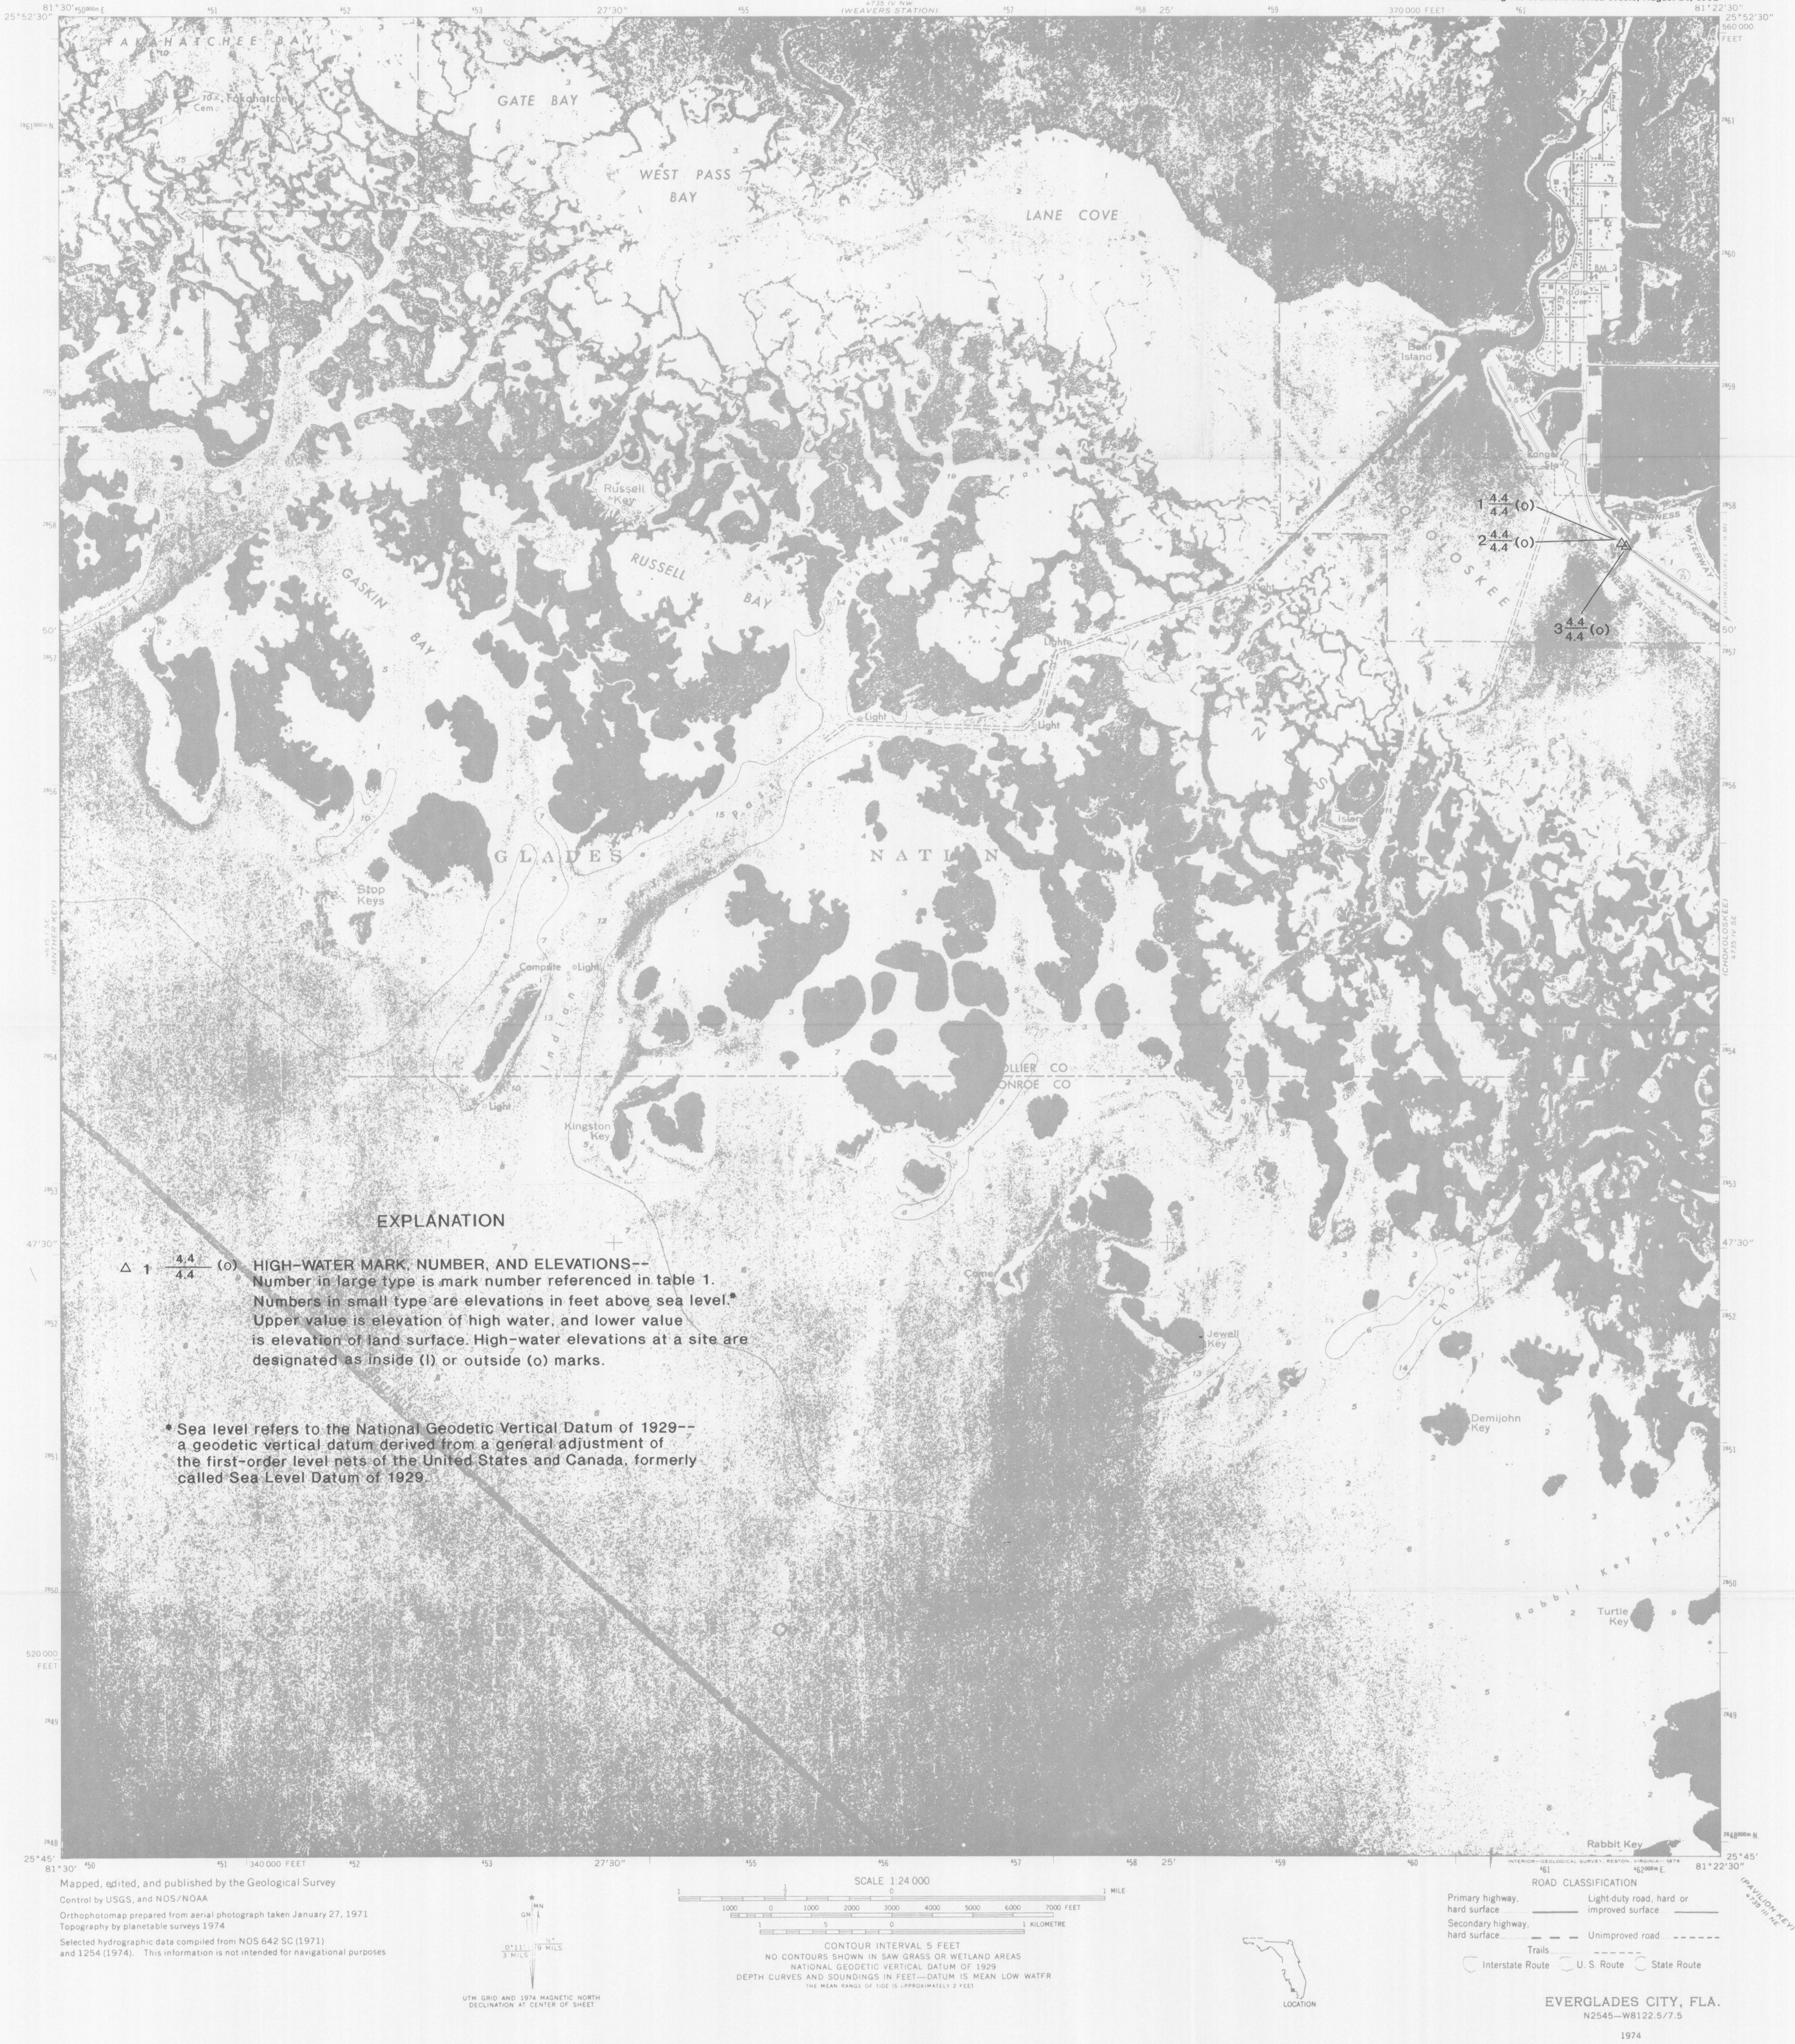
PLATE 17.--MAP SHOWING WATER-SURFACE ELEVATIONS AND HIGH-WATER MARK LOCATIONS IN AREAS AFFECTED BY
HURRICANE ANDREW, EVERGLADES CITY, FLORIDA, QUADRANGLE.
